ELECTRONICALLY CONTROLLED PNEUMATIC BRAKE REVENUE SERVICE TESTS

DOT/FRA/ORD-99/07

January 1999
Final Report

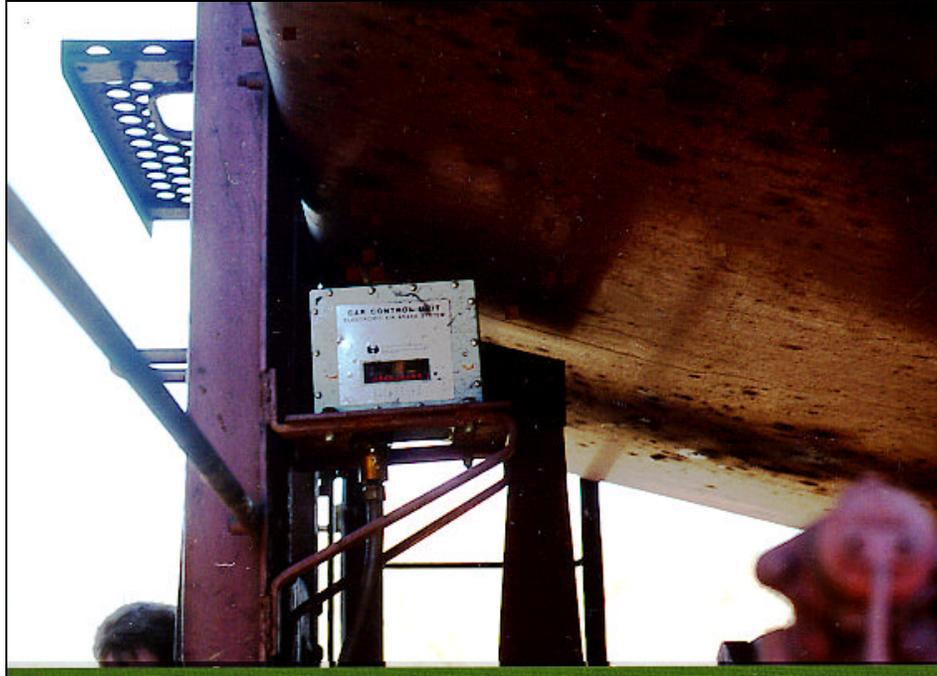
Figure 1. CCD Mounting on Conrail Coal Hopper

Many of the faulty CCDs failed when they were subjected to high-coupling forces, when emptied cars rolled out of the car dumpers and impacted standing cuts of other empty cars. The unglued transceiver chips failed where the pins were previously bent, due to low-cycle fatigue. To compound the problem, the mounting location of these CCDs was on a shelf bracket welded to a vertical structural post between the center sill and the slope sheet (Figure 1). This subjected the already defective CCDs to considerable shock and vibration, resulting in early CCD failure.

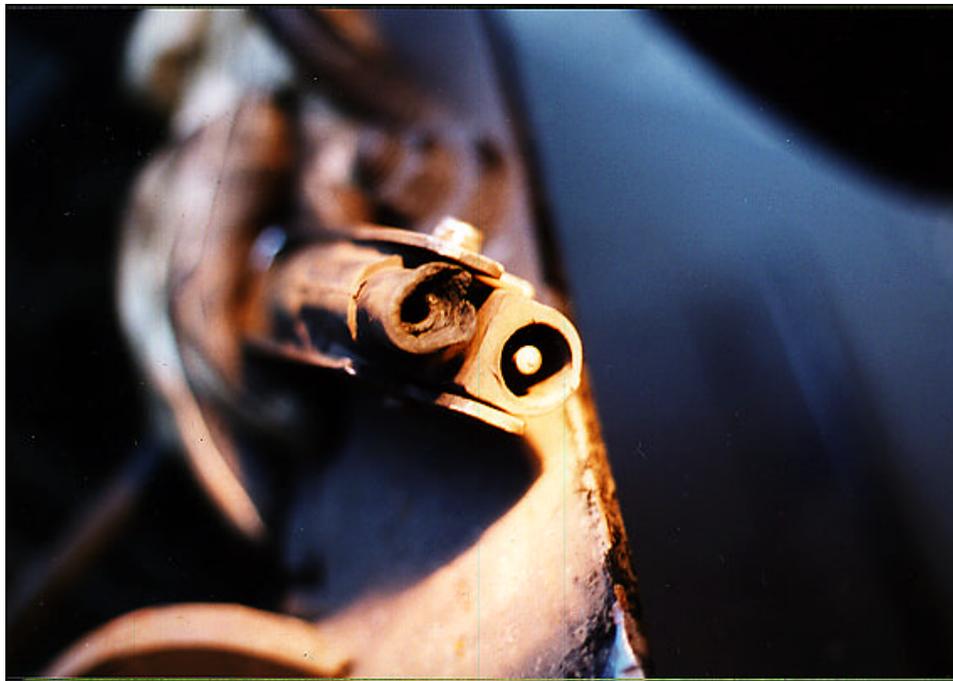
Figure 2. Failed Connector on Conrail

One of the primary problems, which affected the results of the Conrail Test, was the percentage of time that the ECP train was forced to operate as a conventionally braked train. It was planned at the start of the test that the ECP train could be directly compared with the conventional train, but the ECP train ran in ECP mode only 73 percent of the time. Thus the wheel savings shown in the maintenance data was only an indication of what might have been experienced if the ECP train had operated at 100 percent in the ECP mode. Some causes for conventional operation were lack of ECP equipped locomotives, lack of trained crews, and the abnormally high CCD failure rate, discussed above. Another problem was the reliability of the temporary train line connectors used in this test. These connectors had no positive latching mechanisms, and after numerous intentional uncouplings at the car dumper (on average about one uncoupling every five days), they began to cause problems on the road. Figure 2 shows one of these connectors after a road failure.

The “Other ECP Components” defect referred to the failed connectors, some of which were damaged when they were caught between couplers or snagged when the cars were emptied. This problem should be cured with

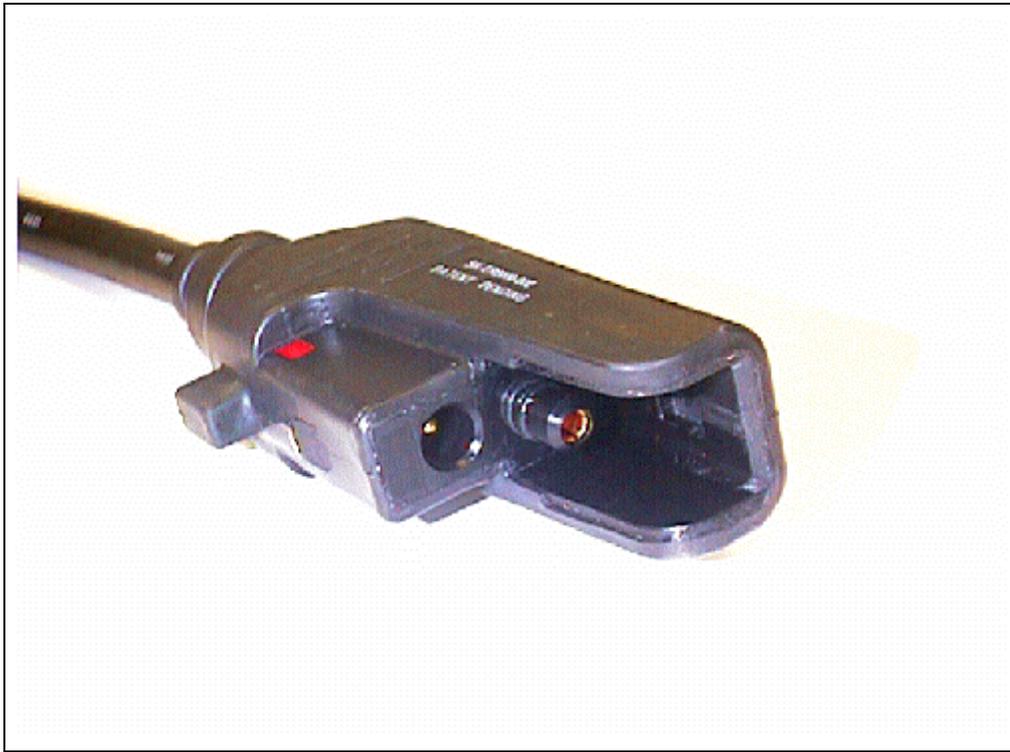
Figure 3. Connector Design adopted by the AAR
selection of a AAR standard connector design, for use in interchange service. The connector failure history experienced during the Conrail Test played an important part in setting the criteria for the selection of the new connector design. The new connector design (Figure 3), adopted by the AAR as part of the ECP-brake specification, is expected to solve the connector problems experienced on Conrail.

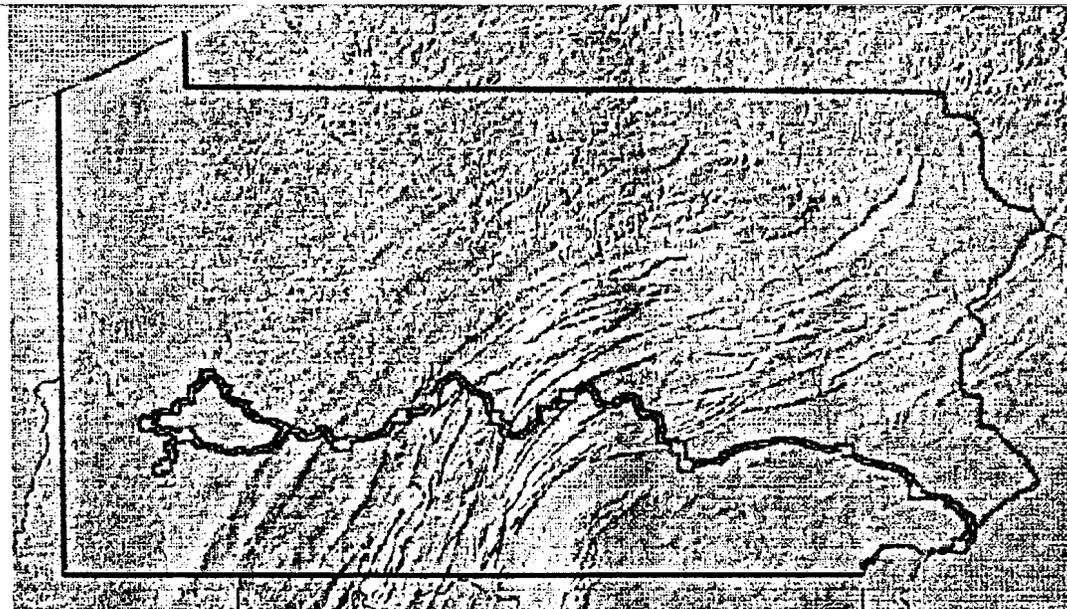
Figure 1 Relief map of test route

The heavy line in the relief map representation of Figure 1 illustrates the test route utilized. Conrail's Shire Oaks Yard is in the southwest corner of Pennsylvania. The coal mines serviced by the test trains are below the Shire Oaks Yard in the extreme southwest corner of the state, and are located on the former Monongahela Railroad. The Cromby power

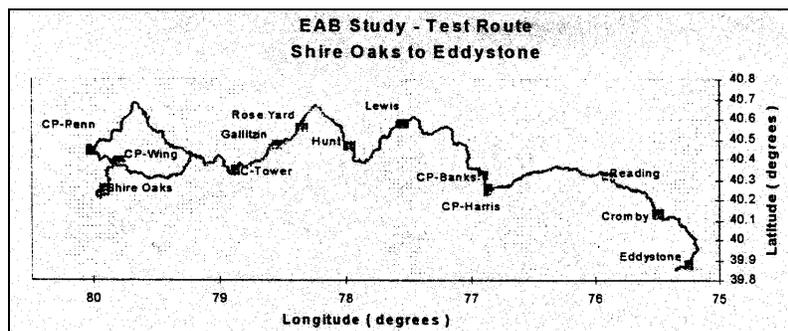
Figure 2 Test route and segment locations

To provide a more specific comparison between the operating dynamics of the EABS trains and the placebo trains during over the road testing, the test route was subdivided into segments with varying terrain and expected operating conditions. Table 1 is a summary of these segments, and Figures 2 and 3 display the position and elevation data that were recorded through these segments. Note in Figure 2 that the eastbound, loaded trains utilized two routes between Shire Oaks Yard on the Mon Line and C-Tower, Johnstown, PA. Initially, the trains were operated from Shire Oaks directly to the Pittsburgh Line at Wilmerding, PA, Control Point (CP)-Wing. These trains continued on the Pittsburgh Line to Johnstown typically receiving additional locomotives, helper-units, on the rear of the train at Pitcairn, PA.

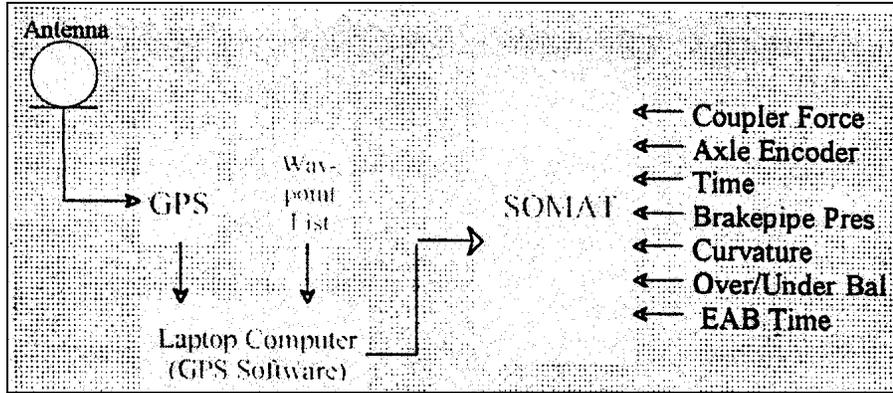
Figure 4 In-train instrumentation

The in-train data were recorded on a SoMat 2100 Field Computer. This system is designed to allow multiple channels of analog, digital, and frequency signals to be filtered, mathematically adjusted, and recorded in a wide variety of manners. For this study, much of the data were recorded in a histogram format, while a computed channel of the drawbar energy was continually summed throughout each test segment. Figure 4 illustrates the

hardware involved and the parameters monitored during the in-train evaluation. The GPS system was continuously polled by a laptop computer to provide instantaneous location readings. These readings were compared to a listing of desired waypoints, which included the thirteen locations illustrated in Figure 2. As each of these waypoints were passed, the laptop computer signaled the SoMat device. This process allowed the data of the previous sub-segment to be stored in SoMat local memory, and new data to begin compiling for the next sub-segment just entered.

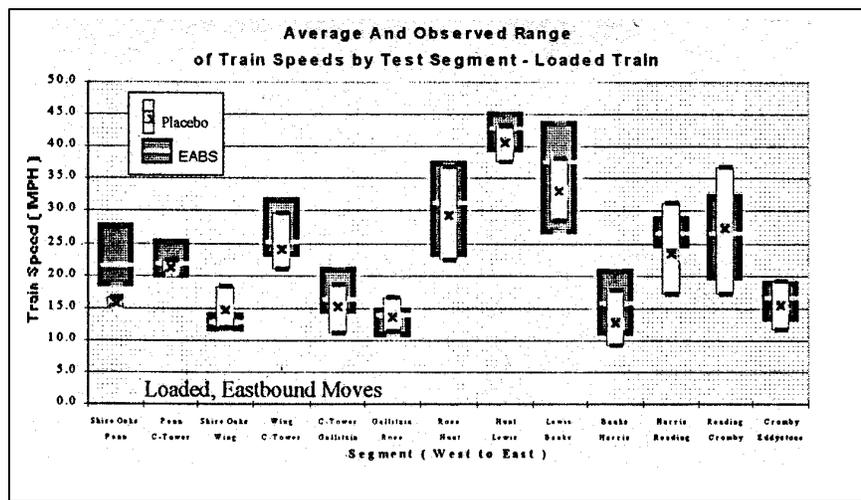
Figure 7 Range of speeds of eastbound shipments

requirements, there seems to be little difference in their average operating speeds, which discounts the former presumption.

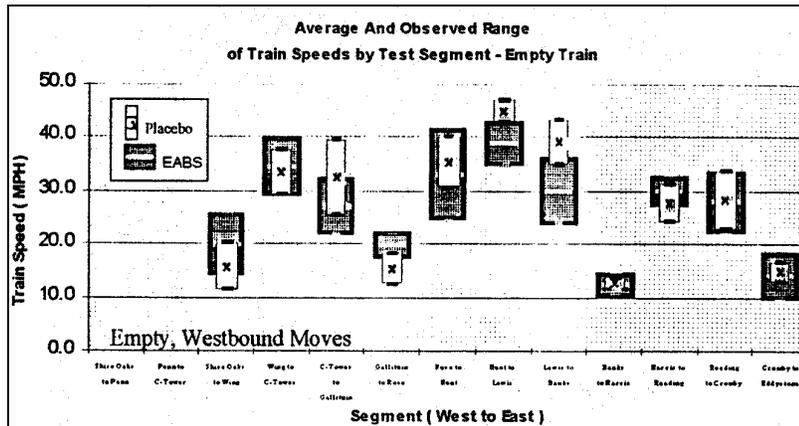
Figure 8 Range of speeds of westbound shipments

acceleration and deceleration of trains. This supports the aggressive train handling postulation, but the segmented average speeds of the EABS trains were not significantly higher than the placebo's speeds.

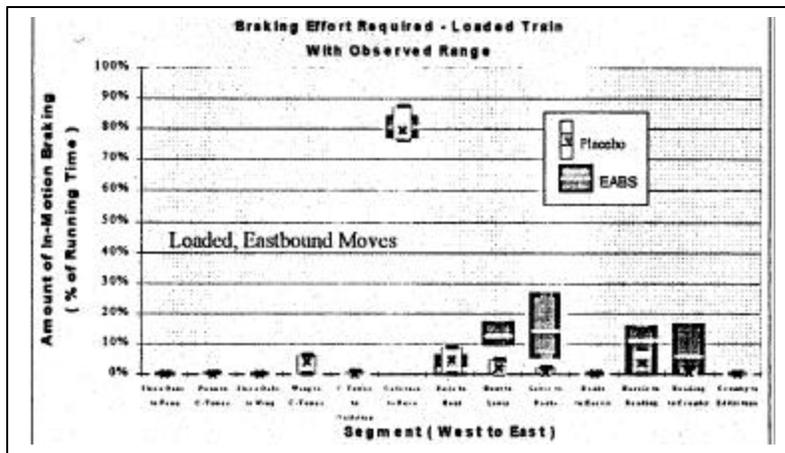
Figure 9 Range of braking effort of eastbound shipments

The braking methods utilized by the Engineers of the test trains did vary. The Engineers of the EABS train utilized the train braking, while their counterparts operating the placebo train did not. This is illustrated in the later, downhill segments of the test route as shown in Figure 9. The crews operating the EABS trains enjoyed utilizing the new braking technology. When braking of the train was required, their response was to apply the ECP brakes rather than the head-end dynamic brakes. The crews of the placebo train would be more likely to use locomotive dynamic braking, as in normal train operation. These alternate methods of train braking affect the resultant coupler forces differently.

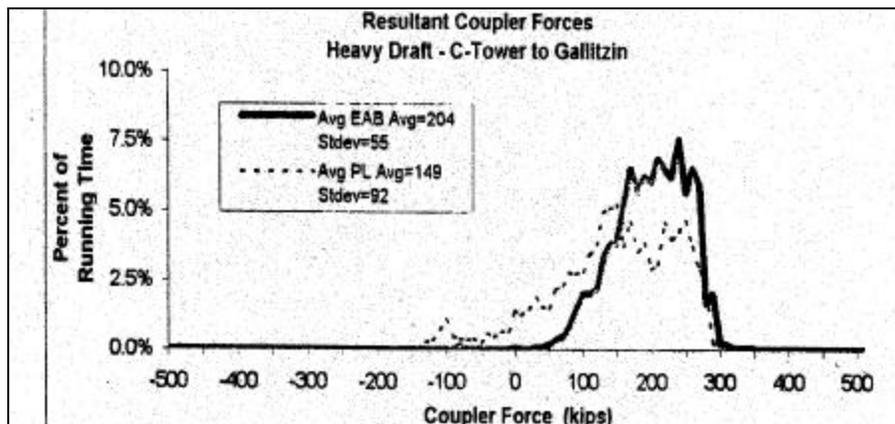
Figure 10 Head-end forces, heavy draft

buff and draft operations were analyzed. Referring to the elevation information of Figure 3, two segments of the eastbound trips were used to provide this comparison, the uphill run from C-Tower to Gallitzin, and the downhill segment from Gallitzin to Rose. Coupler force data were compiled in a histogram format whenever the train speed was greater than two miles per hour. The coupler force data in the histogram could range from -500 kips (compressive, buff forces) to ± 500 kips (tensile, draft forces) in 10 kip increments. Used for the comparative analysis were six EABS test runs averaged to represent a typical ECP train, and five placebo test runs averaged with one EABS test run that operated in conventional braking mode to represent the typical placebo (PL) train. Each of these trains were aided up and over these segments by a pair of helper locomotives on the rear of the train. Additionally, the collected histogram data were converted from counts per cell, to a percentage of total counts recorded. This normalization process provided a direct comparison between the trains and illustrates the distribution of the head-end coupler forces while the train is in motion. The resultant, normalized histograms are illustrated in Figures 10 and 11 for the draft and buff operations, respectively.

Among the anticipated benefits of the ECP brake system is improved train handling resulting in reduced costs of equipment, track, roadbed, lading, and collateral damage.⁴ The resultant coupler forces illustrated in Figures 10 and 11 indicate that the EABS trains did have less variation in dynamic coupler action than did the placebo trains. However, one must be cautious in the interpretation of these data. The data collected cannot be used to describe the influence that the helper locomotives had on the train dynamics, and the EABS trains regularly had more braking and tractive effort available to control the train. Three SD-60M locomotives always powered the EABS trains while two locomotives powered the placebo trains. The effect of the additional tractive and braking effort can be seen in these figures by the higher average draft and buff forces, respectively.

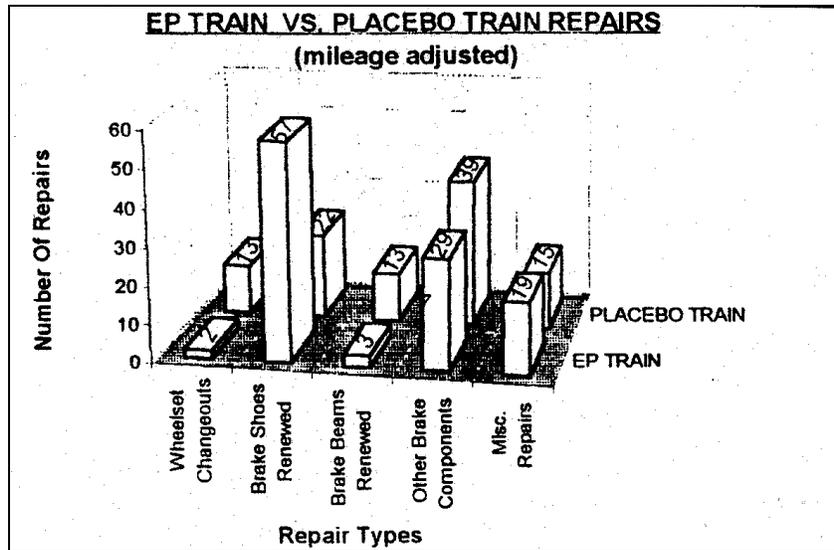
Figure 12 Mileage adjusted repair requirements.

As seen in Figure 12, the wheel change out rate on the EABS equipped cars was much lower than the cars of the placebo train. When adjusted for mileage, the EABS equipped train had two sets of wheels replaced versus thirteen wheel sets for cars of the placebo train, it is worth noting that the two wheel sets changed on the EABS train were from a single car reported to have slid flats caused by a dragging hand brake. Regardless of the braking technology, human error is still present.

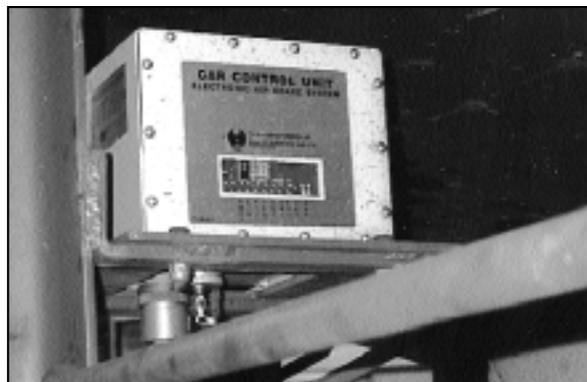
Exhibit 1. CCD Mounting Arrangement

The test data were collected using battery-operated, portable data-collection systems. The sensor package consisted of a triaxial (vertical, lateral, longitudinal) cluster of accelerometers, mounted on a rigid base plate. Both the data-collection system and the accelerometer package were rigidly clamped to the car structure, using heavy-duty C-clamps.

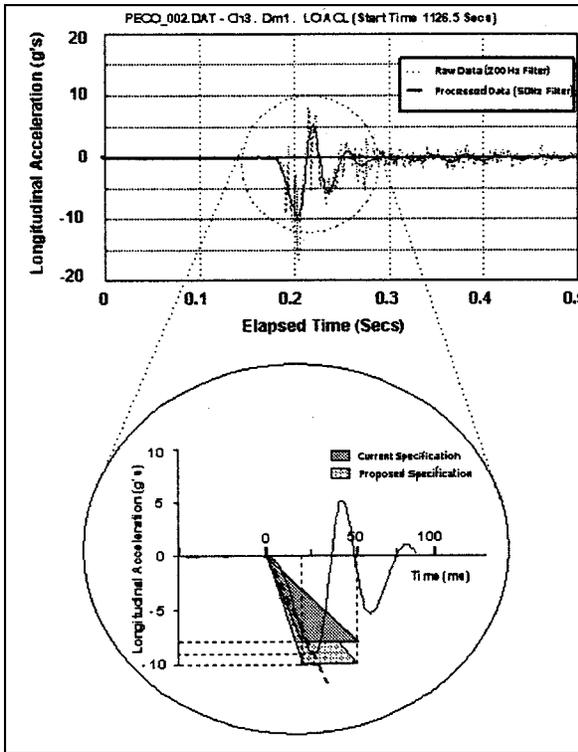
Exhibit 2. Longitudinal Impact Data

The test data collected during the dumping operation consisted of two-second bursts of acceleration, triggered by an exceedance of ± 0.5 g in any of the three axes, with a full-scale value of ± 20 G. A sample rate of 1,000 samples/second and a filter setting of 200 Hz was used. For the over-the-road testing, a trigger level of ± 0.4 g was
